INDOOR AIR QUALITY ASSESSMENT

**Douglas G. Waybright Elementary School
25 Talbot St
Saugus, MA 01906**

Prepared by:
Massachusetts Department of Public Health
Center for Environmental Health
Emergency Response/Indoor Air Quality Program
August 2006

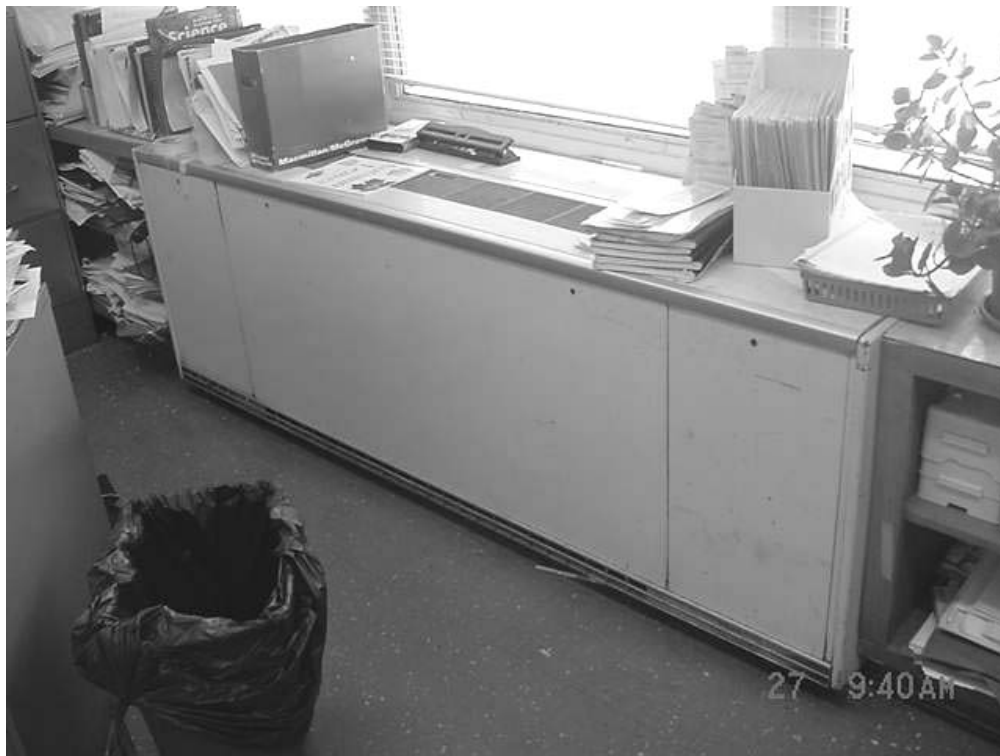
Picture 1

Fresh air in classrooms is supplied by unit ventilator (univent) systems ([Picture 1](#)). A univent draws air from the outdoors through a fresh air intake located on the exterior wall of the building (Picture 2) and returns air through an air intake located at the base of each unit (Figure 1). Fresh and return air are mixed, filtered, heated and provided to classrooms through an air diffuser located in the top of the unit. As mentioned, all univents had been deactivated at the

Classroom Univent

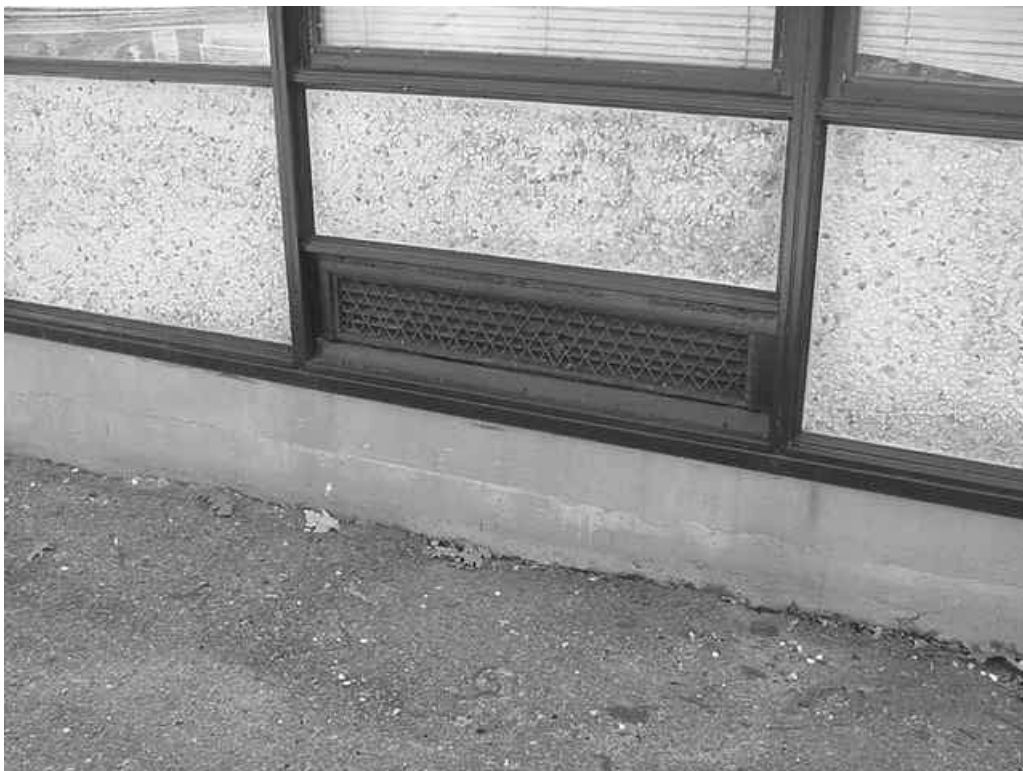
Picture 2

Univent Fresh Air Intake

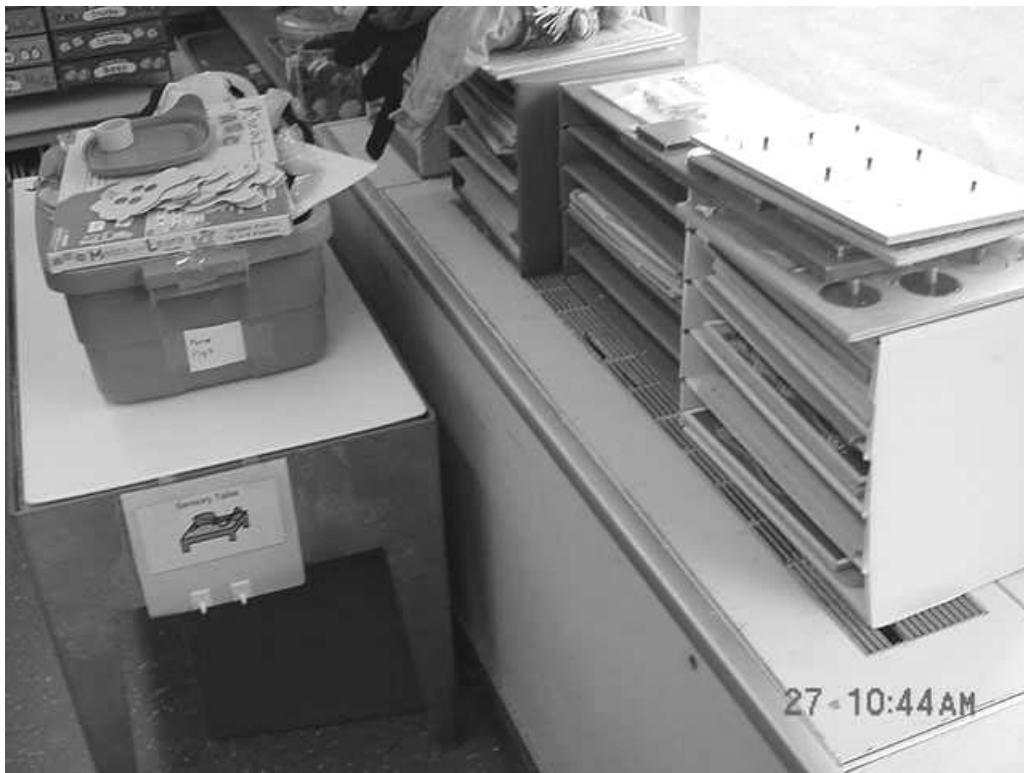
Picture 3

time of the assessment and were reported to be used as heating units only (e.g., during fall/winter). Obstructions to airflow, such as papers and books stored on univents and items placed in front of univent returns, were seen in a number of classrooms (Picture 3). In order for univents to provide fresh air as designed, these units must be activated and allowed to operate while rooms are occupied. Univent return vents and diffusers must also remain free of obstructions.

Items Obstructing Univent Air Diffuser and Return Vent (Bottom Front)

3. Remove all obstructions from univents and exhaust vents to facilitate airflow. Remove coat hooks in front of exhaust vents.
4. Close classroom doors to improve air exchange.

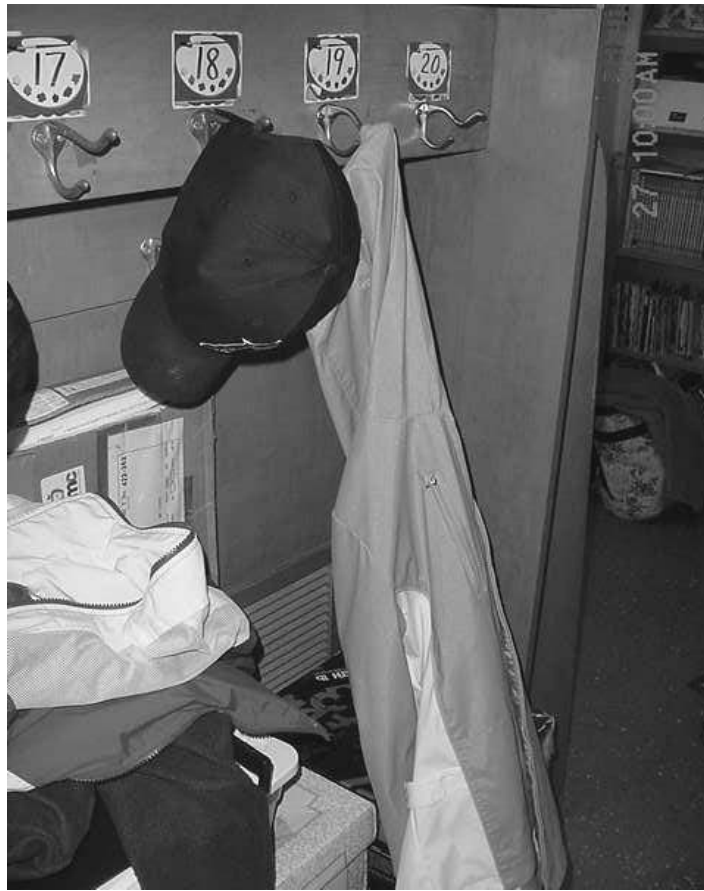
Picture 5

Exhaust ventilation is provided by vents located on the rear side of an interior wall/divider in each classroom (Pictures 4 and 5). Vents are ducted beneath classrooms out an exhaust grill located on the exterior of the building (Picture 6). The exhaust vents are prone to obstruction by items placed or hung in front of the vents (Picture 5). In addition, the location of the vents is not conducive to air exchange (e.g., on the opposite side of the wall to univents and occupants), reducing the effectiveness of the exhaust vent to remove common environmental pollutants from the classroom itself. As with the univents, in order to function properly, exhaust vents must remain free of obstructions.

Exhaust Vent on the Opposite Side of Wall Interior Wall/Divider, Note Coat Hooks and Partially Obstructed Vent

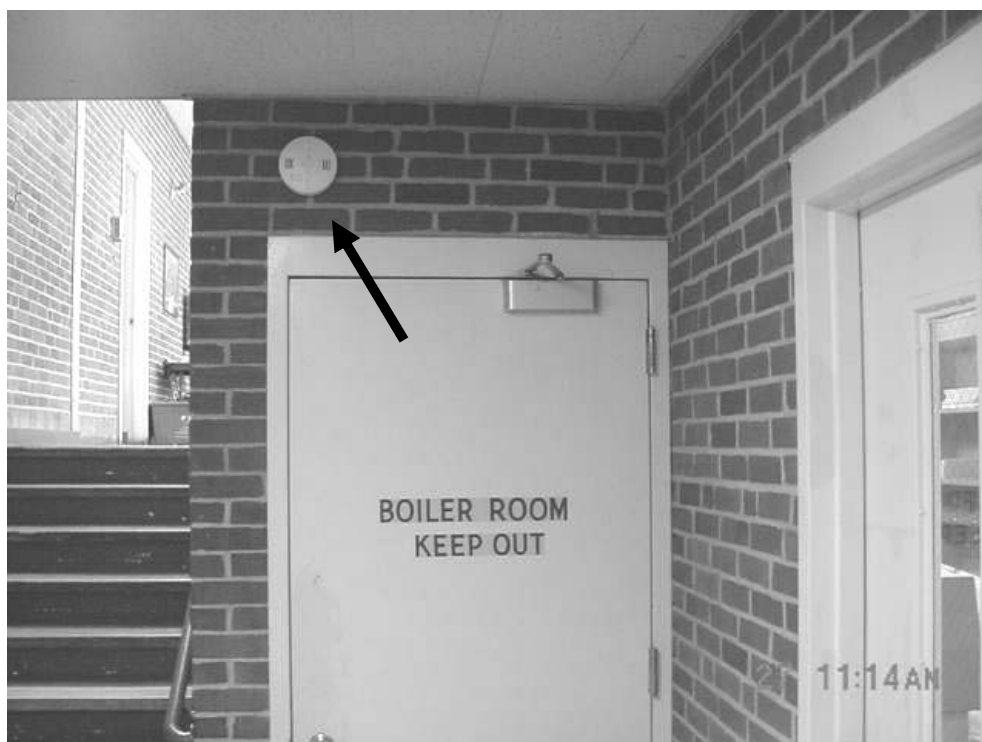
Picture 8

Carbon Monoxide Detector outside of Boiler Room

14. Test and replace carbon monoxide detector(s) as per the manufacture's recommendations to ensure proper working order.
15. Consider changing univent filters on a more frequent basis to prevent reduced airflow to classrooms. Vacuum interior of units prior to activation to prevent the aerosolization of dirt, dust and particulates.

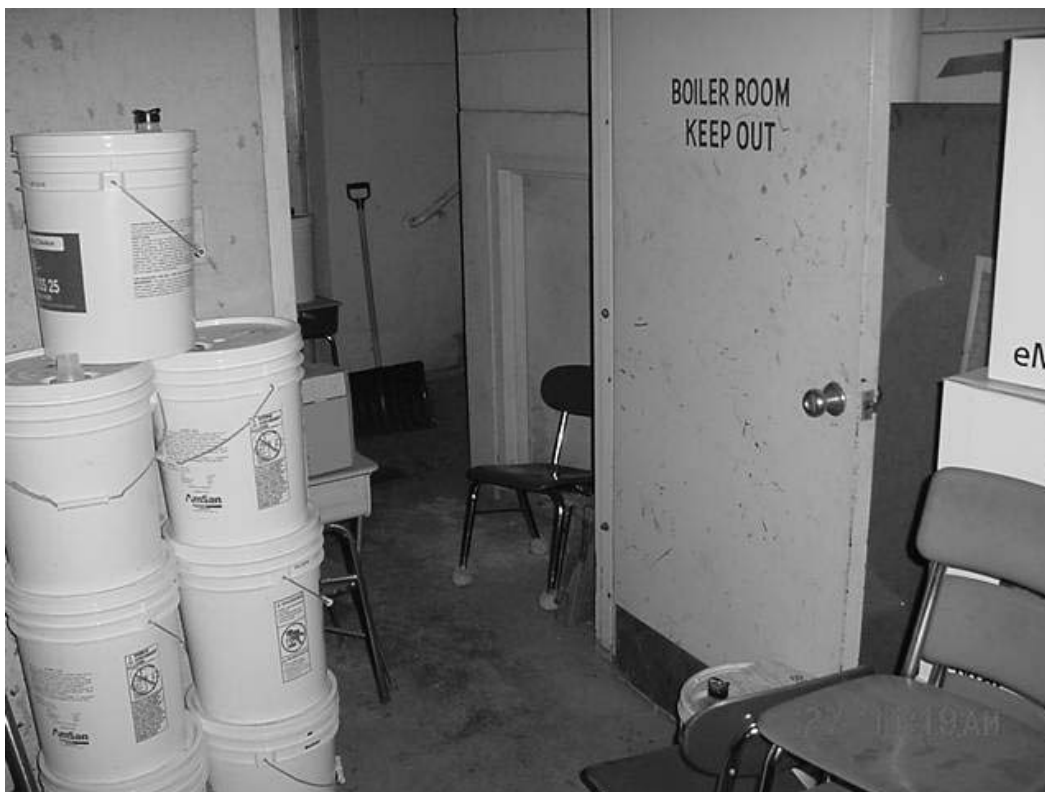
Picture 9

Interior Door to Boiler Room Propped Open

12. Store cleaning products properly and out of reach of students. Ensure spray bottles are properly labeled.
13. Keep boiler room doors closed and install weather stripping underneath hallway door (shown in Pictures 8 and 10) to prevent the migration of odors and particulates.

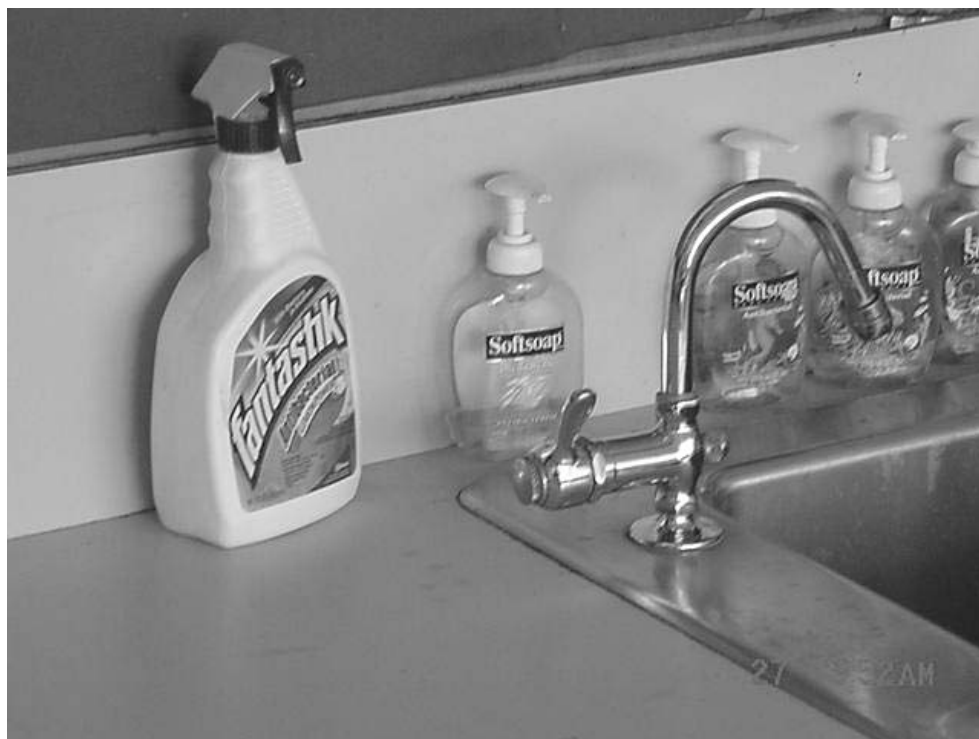
Picture 11

Cleaning products were found on countertops and in unlocked cabinets beneath sinks in some classrooms (Picture 11). Like dry erase materials, cleaning products contain VOCs and other chemicals that can be irritating to the eyes, nose and throat of sensitive individuals.

Spray Cleaning Product on Counter of Classroom

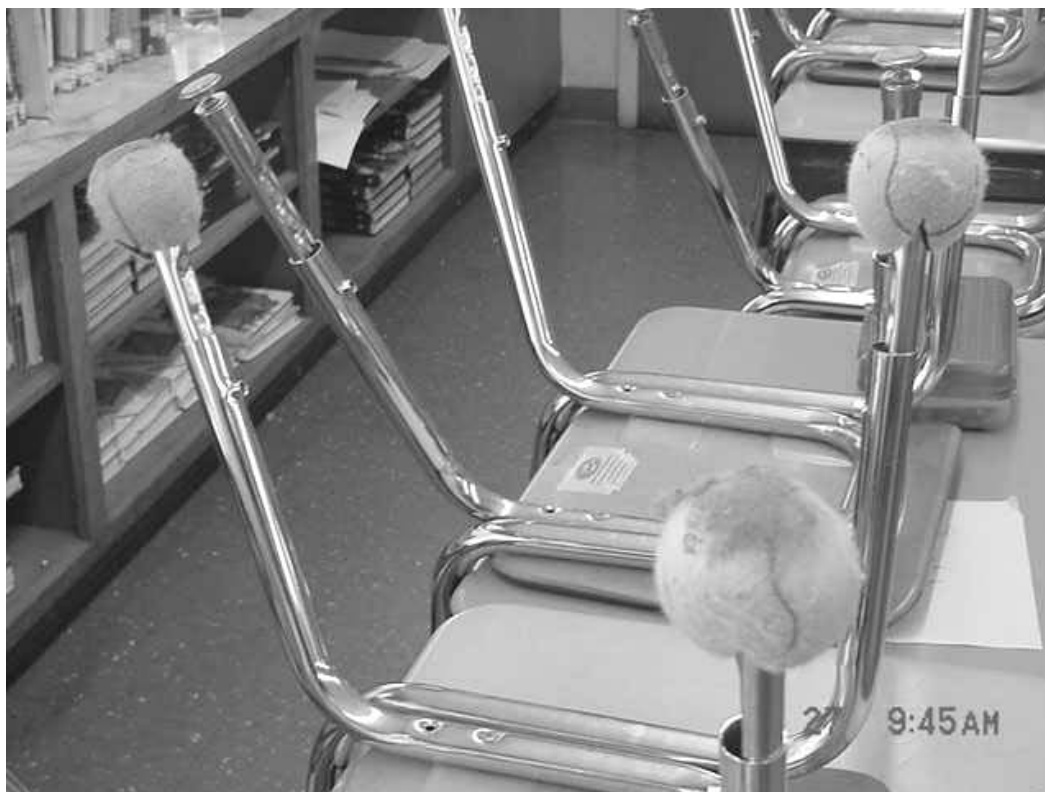
Picture 12

In an effort to reduce noise from sliding chairs, tennis balls had been sliced open and placed on chair legs (Picture 12). Tennis balls are made of a number of materials that are a source of respiratory irritants. Constant wearing of tennis balls can produce fibers and cause TVOCs to off-gas. Tennis balls are made with a natural rubber latex bladder, which becomes abraded when used as a chair leg pad. Use of tennis balls in this manner may introduce latex dust into the school environment. Some individuals are highly allergic to latex (e.g., spina bifida patients) (SBAA, 2001). It is recommended that the use of materials containing latex be limited in buildings to reduce the likelihood of symptoms in sensitive individuals (NIOSH, 1997). A question and answer sheet concerning latex allergy is attached as [Appendix B](#) (NIOSH, 1998).

Tennis Balls on Chair Legs

21. Consider discontinuing the use of tennis balls on chair legs to prevent latex dust generation. Alternative “glides” can commonly be purchased from office supply stores; see Picture 20 for an example.

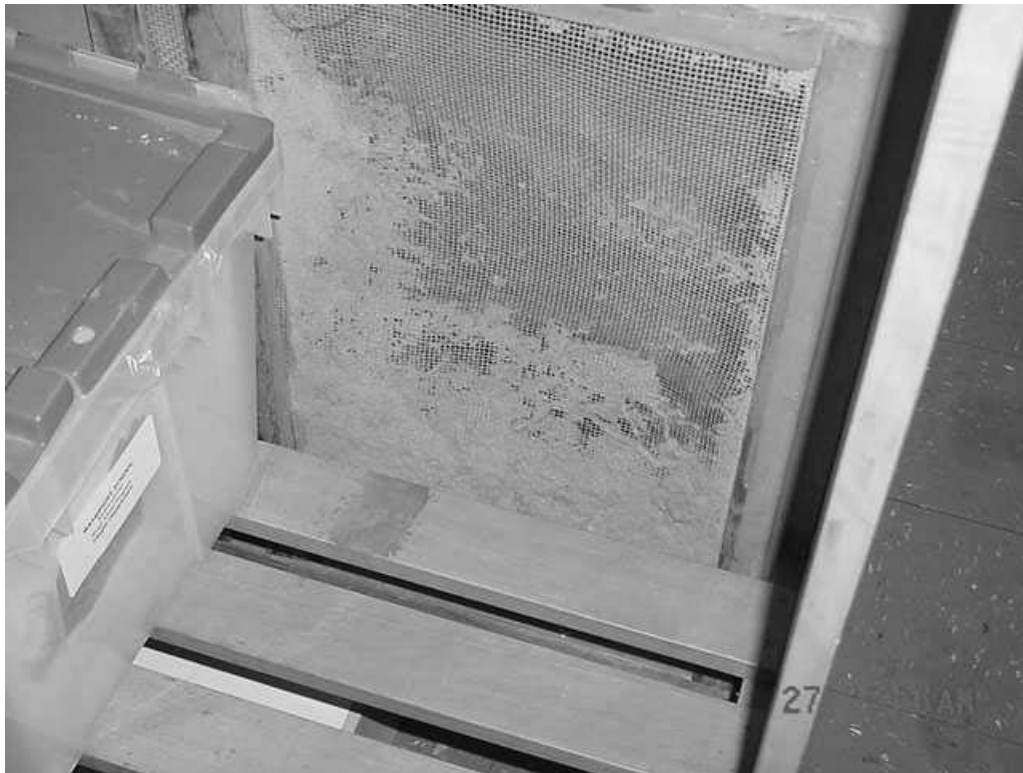
Picture 13

Other conditions that can affect indoor air quality were noted during the assessment. A number of personal fans, ceiling and wall-mounted exhaust vents were occluded with dust (Pictures 13 through 15). Dust can be a source for eye and respiratory irritation. If exhaust vents are not functioning, backdrafting can occur and aerosolize dust particles. Dust particles can also be aerosolized when fans are activated. Once aerosolized, these materials can accumulate on flat

Wall-Mounted Exhaust Vent Occluded with Dust

18. Clean exhaust/return vents and personal fans periodically of accumulated dust to prevent the aerosolization of dirt, dust and particulates.
19. Store nests in resealable bags, away from ventilation sources.

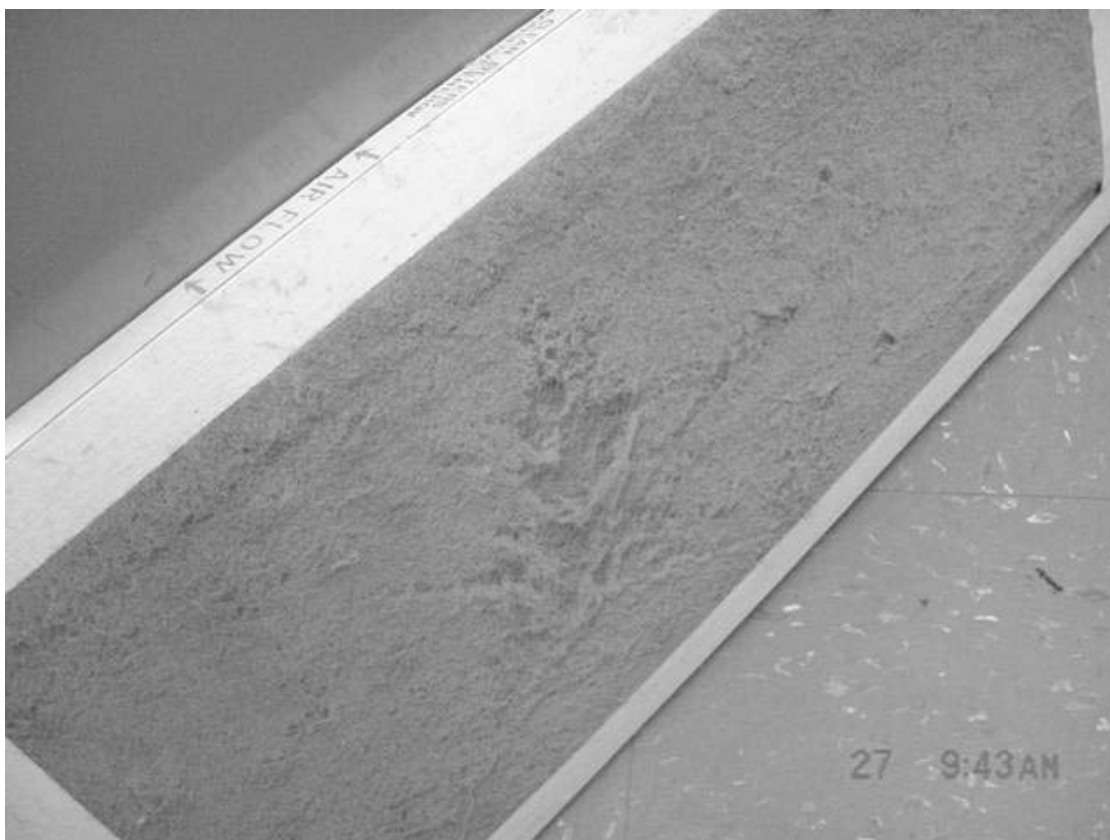
Picture 16

Univent filters are reportedly changed once a year. CEH staff inspected and found univent filters in a number of areas to be coated with dirt/dust (Picture 16). A debris-saturated filter can obstruct airflow and may serve as a reservoir of particulates that can be re-aerosolized and distributed to occupied areas via the ventilation system.

Univent Filter Occluded with Dust

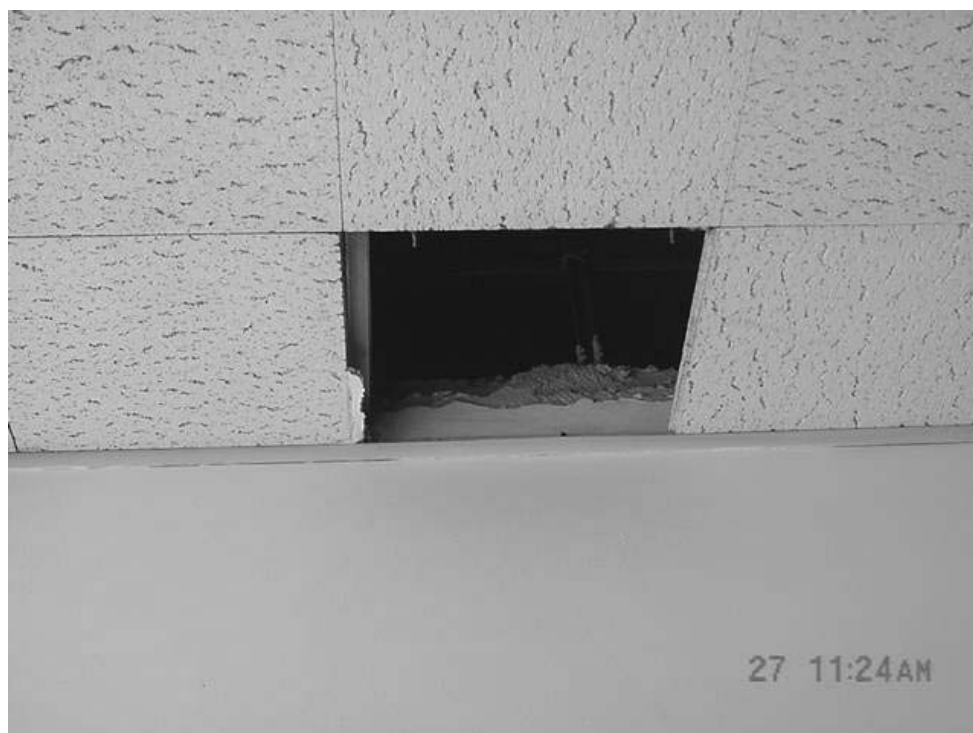
Picture 17

Missing Ceiling Tile in Special Education Classroom

16. Replace missing ceiling tiles to prevent the egress of drafts, odors and particulate matter into occupied areas.

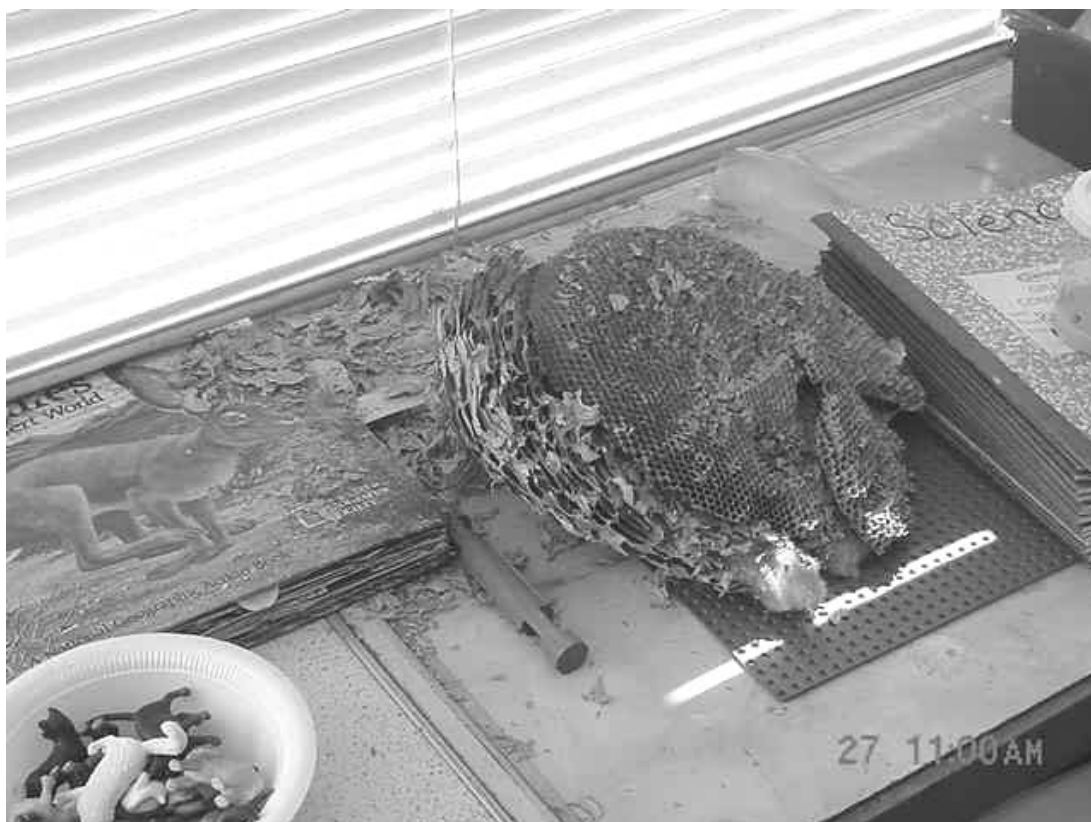
Picture 18

An inactive insect nest was observed in one classroom (Picture 18). Nests can contain bacteria and may be a source of allergenic material. Nests should be placed in resealable bags to prevent aerosolization of allergenic material.

Inactive Bee/Wasp Nest in Classroom

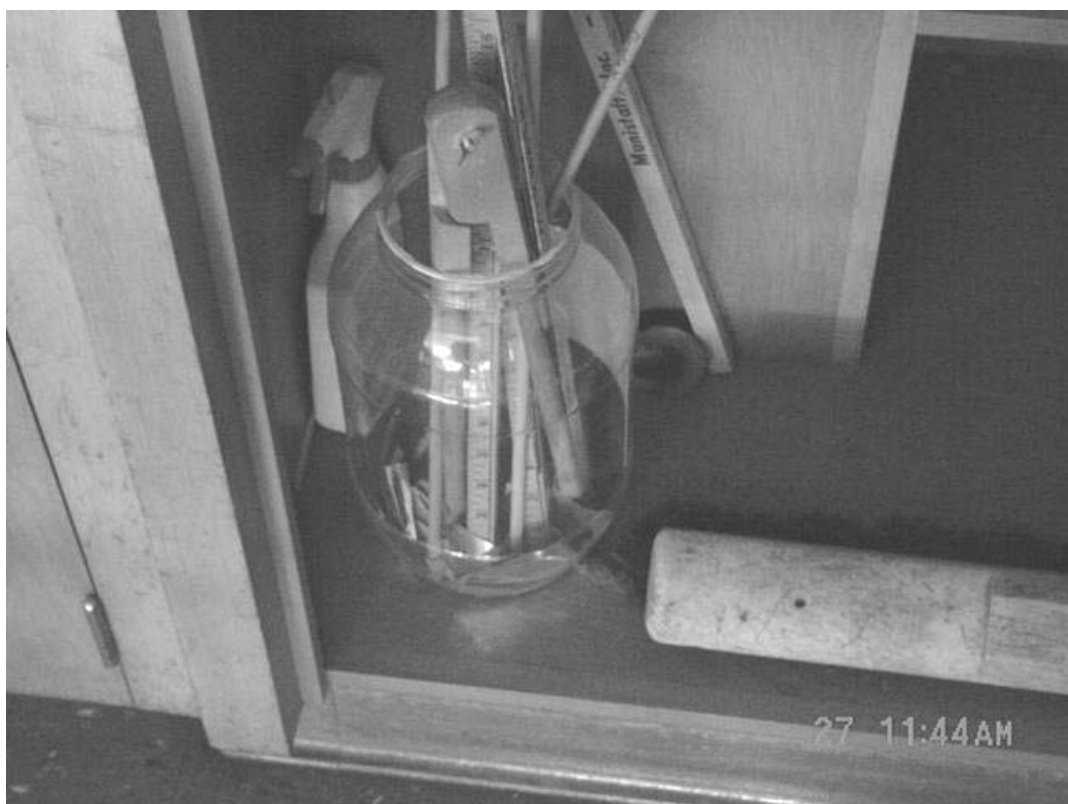
Picture 19

Lastly, pungent odors were reported from the closet of classroom 4. CEH staff examined conditions in the closet and traced the odor to a food jar that was being used for storage of items (Picture 19). It was recommended that the container be discarded and that all porous items (e.g., books, paper) that may have absorbed odors attempt to be aired out or discarded. Reuse of food containers is not recommended since food residue adhering to the surface may become a source for odors and/or serve to attract pests.

Food Container in Coat Closet of Classroom 4

20. Ensure food container is removed from coat closet in classroom 4 and that any porous items (e.g., books, paper) that may have absorbed odors are aired out or discarded.

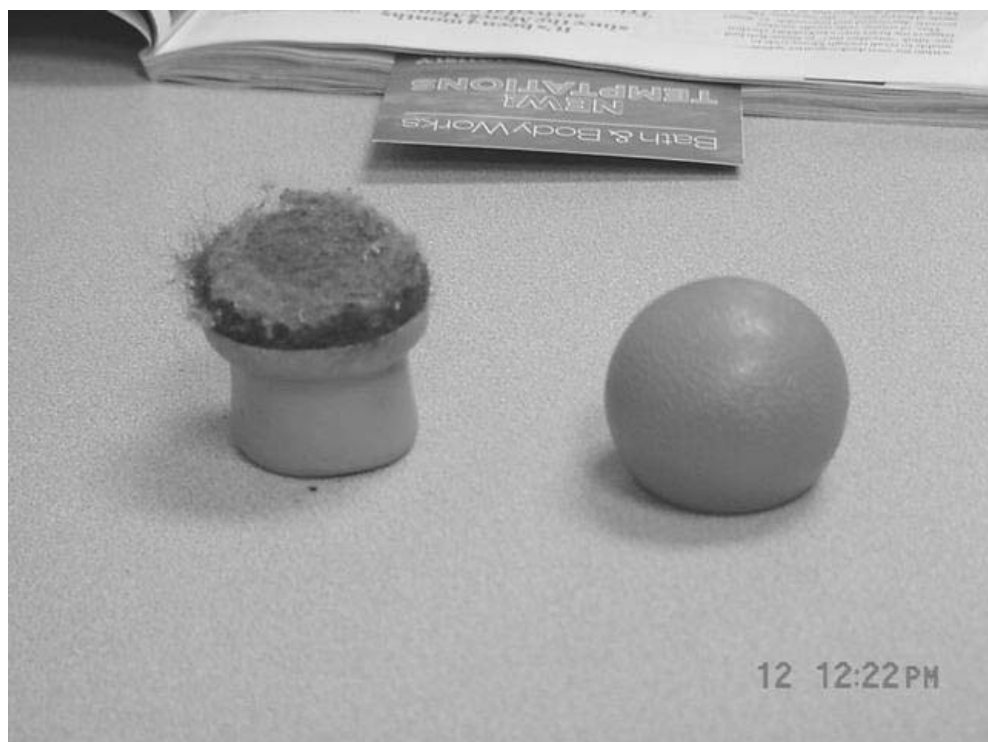
Picture 20

“Glides” for Chair Legs that can be used as an Alternative to Tennis Balls
